## Simple measures and techniques help safeguard historic buildings in a changing climate

### Ventilation measures reduce wall moisture in Norway's historic churches

*Changing the cladding's position prepared Mandal Church in Lindesnes for more humid weather conditions and helped preserve the building's future by reducing wall moisture caused by milder temperatures and increased humidity, which improved its stability.*

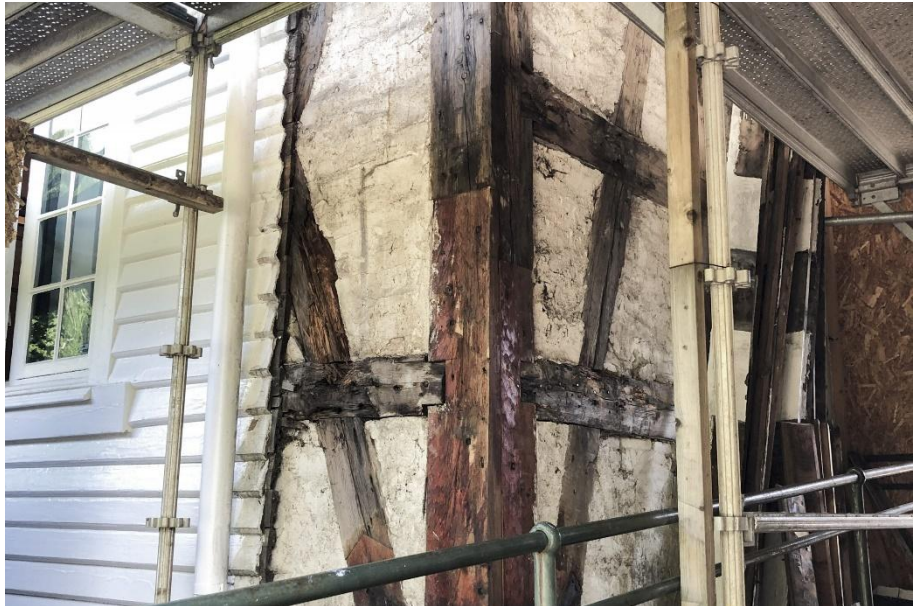
*Figure 2: An uncovered corner of Mandal church showing how the cladding was connected directly to the wooden construction. Fungi and rot had damaged the structure. Image Credit: Tanja Røskar/Multiconsult.*

The restoration project at Mandal Church aimed to better protect the church from future climate change impacts and avoid past mistakes. When the project team dismantled the cladding on the entire church, they found that 90% of it remained in good condition and usable. To improve ventilation, they remounted the cladding with a 25 mm gap outside the timber construction. This gap prevents rotting by ensuring airflow, which keeps the conditions dry despite increased humidity due to climate change. A diffusion-open wind barrier made of airtight cardboard was also added, placed on the outer wall to allow moisture to escape without letting drafts in. As well as contributing to moisture control, sealing air leaks is a simple yet effective measure that saves energy and enhances comfort in the building.
